Moblas 4: Station Range Accuracy Issues and Required Corrective Engineering Actions

Thomas Varghese, John Ries

Moblas 4: Range Bias Issues

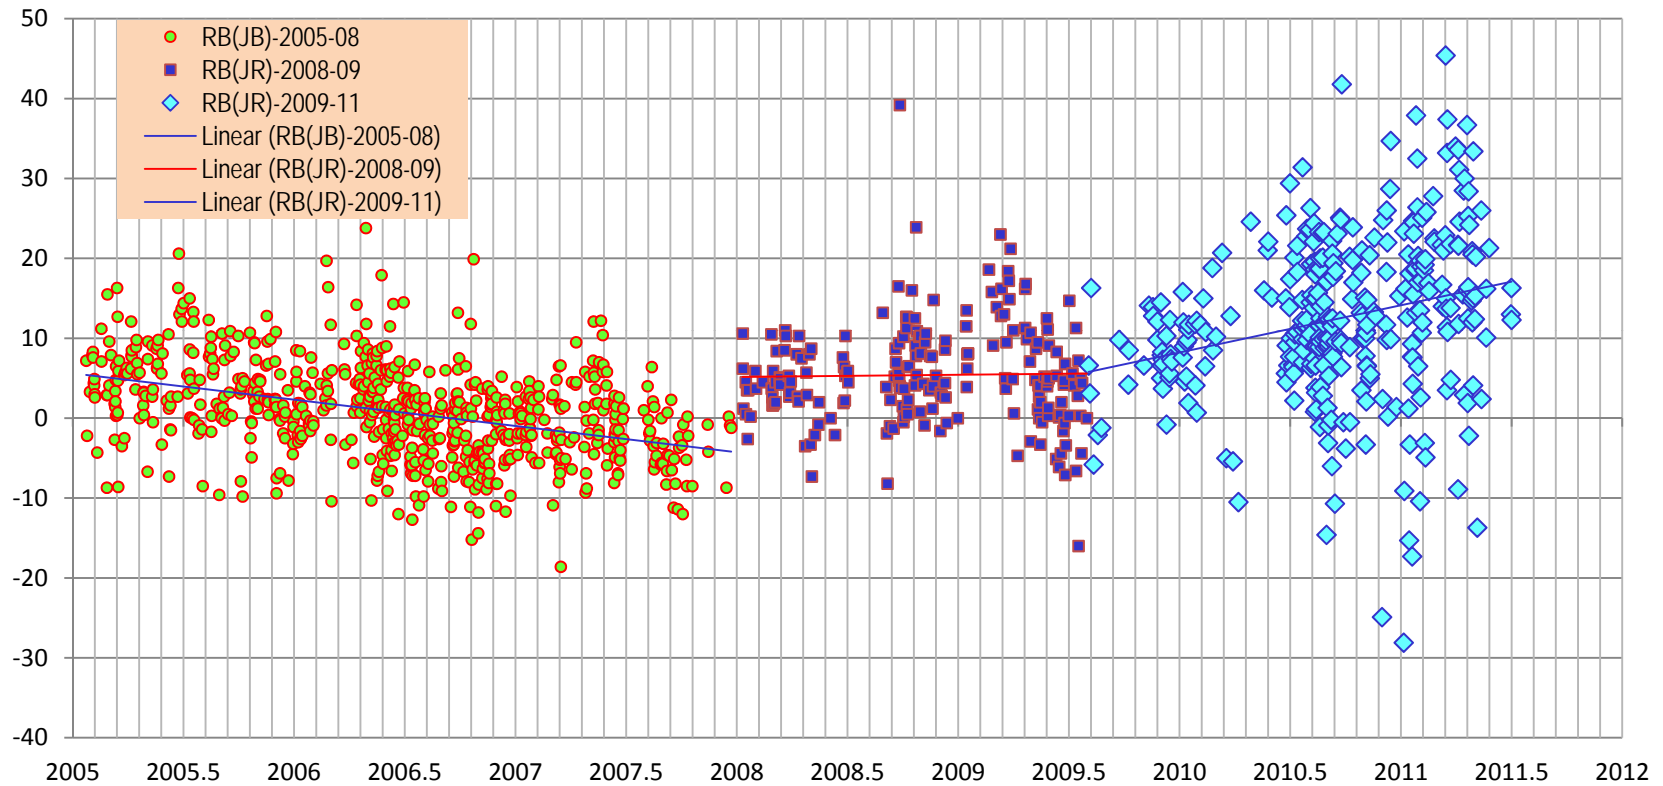
Moblas 4 : Lageos Multi Year RB Trend

1. Monument Peak has been showing a monotonically increasing multiyear range bias (RB) reaching ~2cm in 2011; <see attached>
2. Time bias (TB) issues (increased scatter) were also observed on Lageos 1&2, Starlette and Stella, and Ajisai passes, apparently starting around the end of May 2010, and degrading further starting around the beginning of August 2011 ;

5. Extensive station survey was done in Nov 2011 to ascertain station height changes or calibration target changes; performed measurements were consistent at the 2-3 mm level to the previous survey performed in 2003;

6. GPS measurements performed in the proximity of M4 does not support the vertical changes observed by SLR;
7. There appears to be NO seasonal dependence to explain the magnitude of this problem;

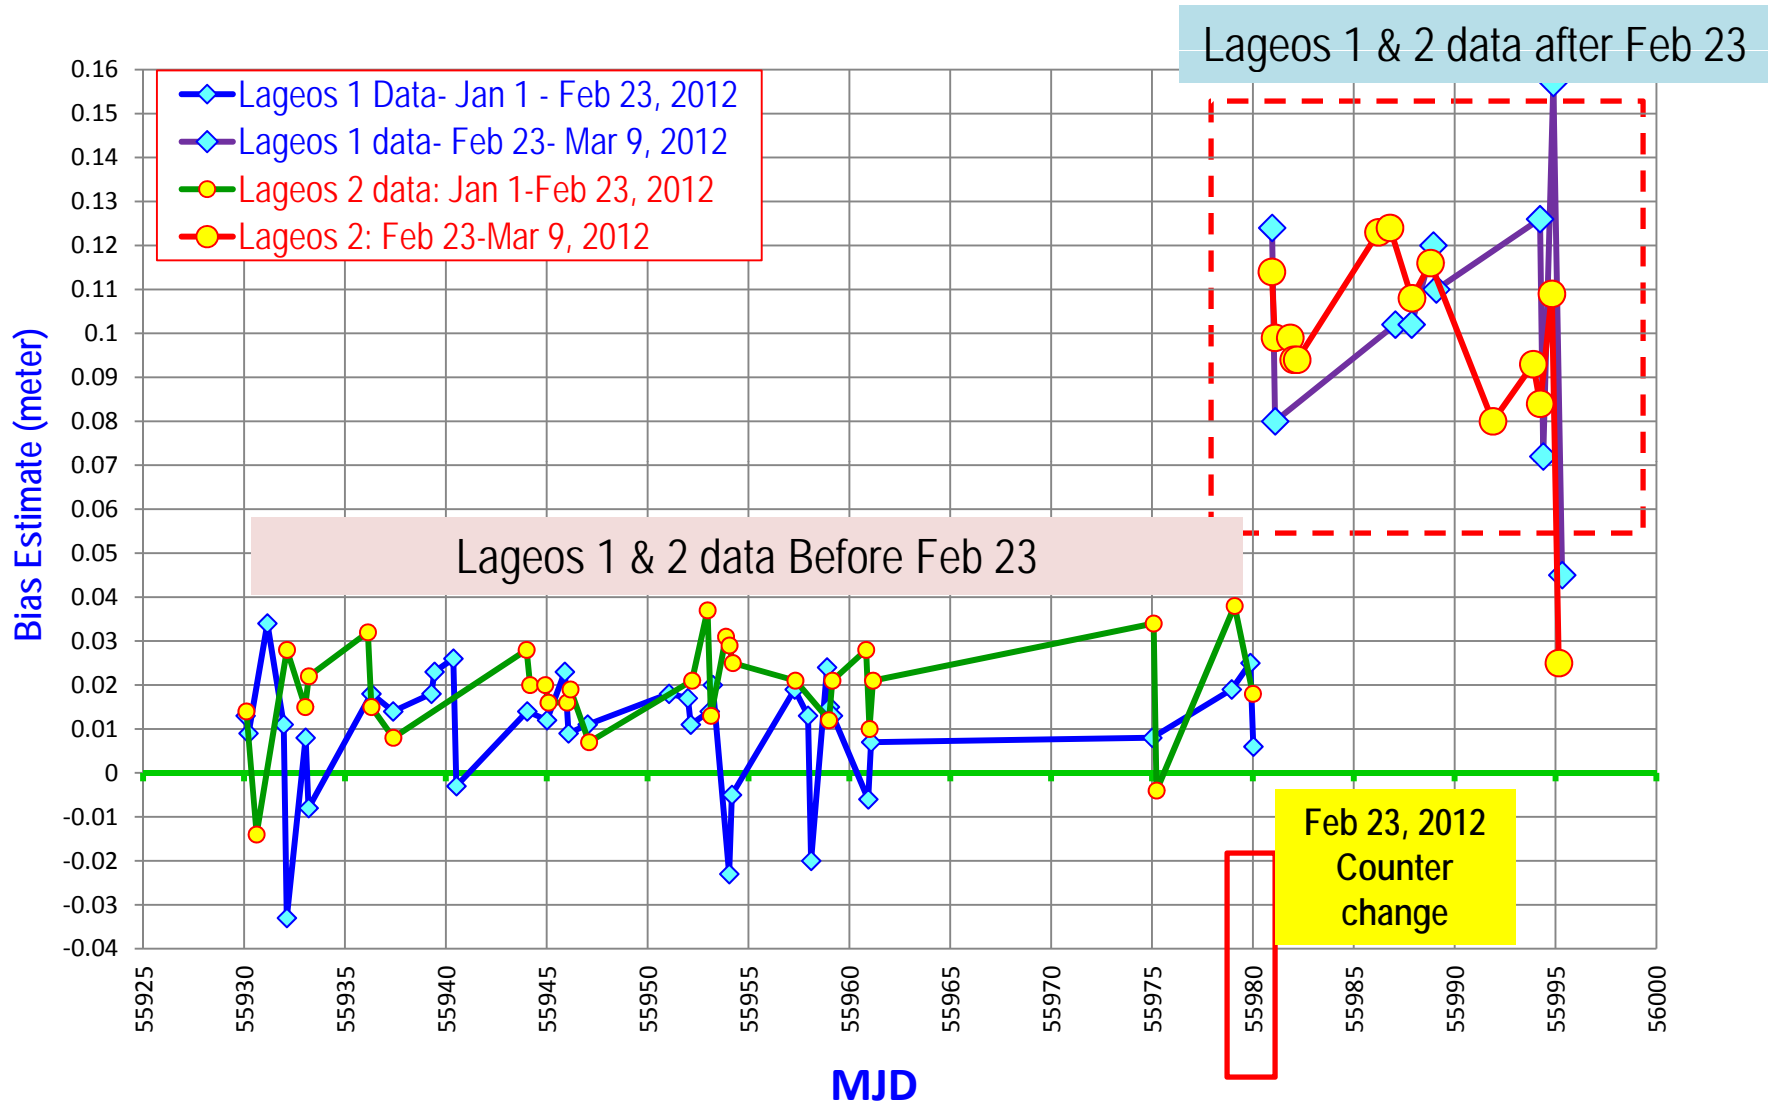
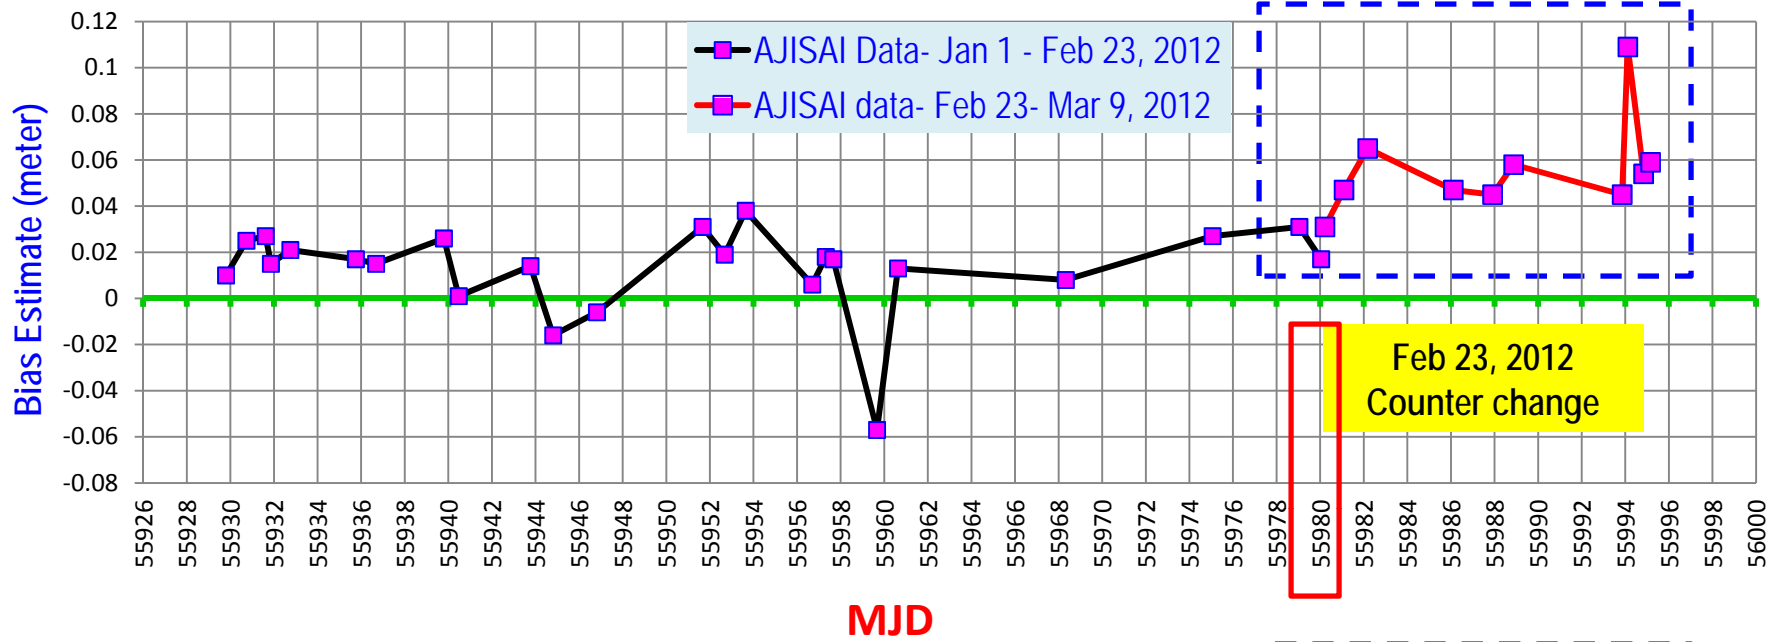
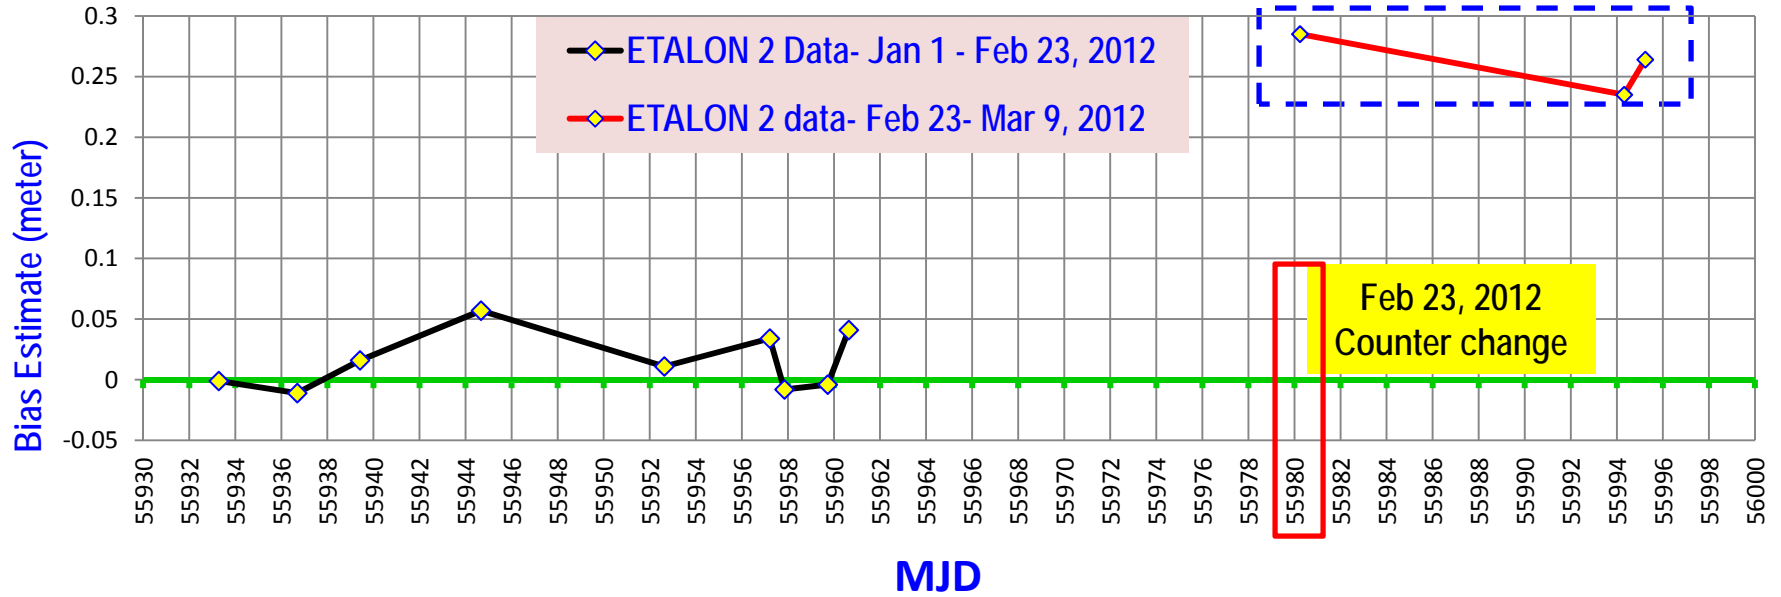
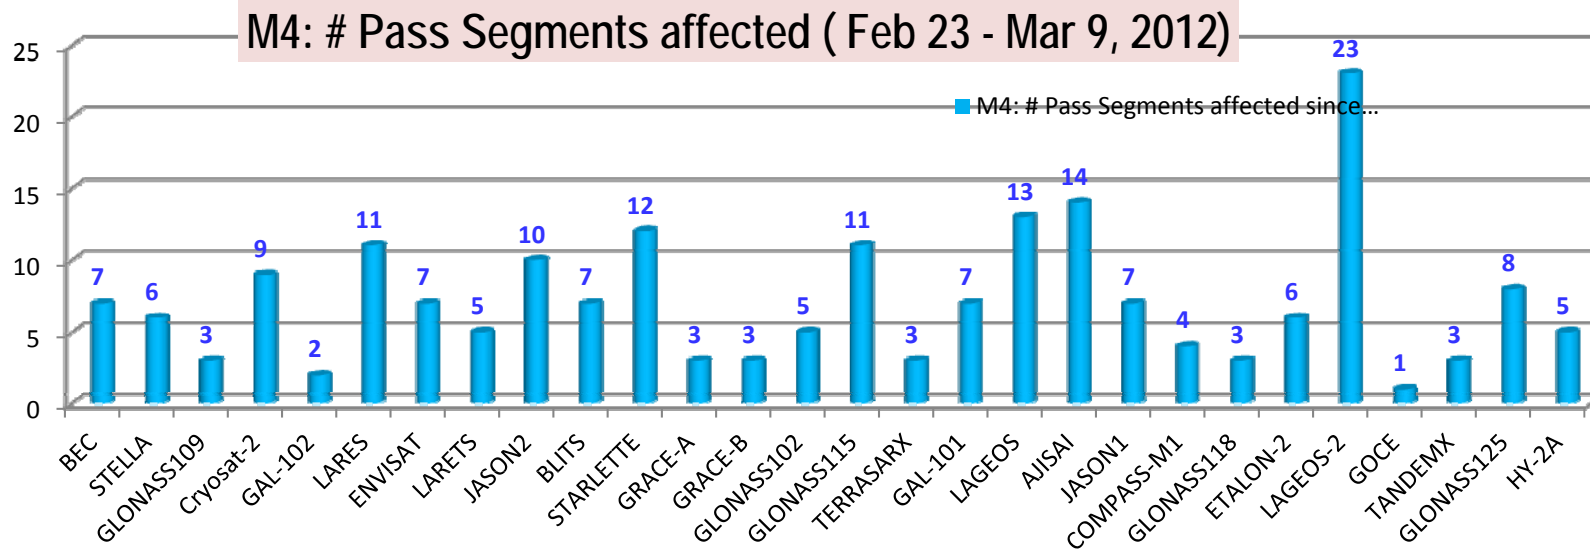
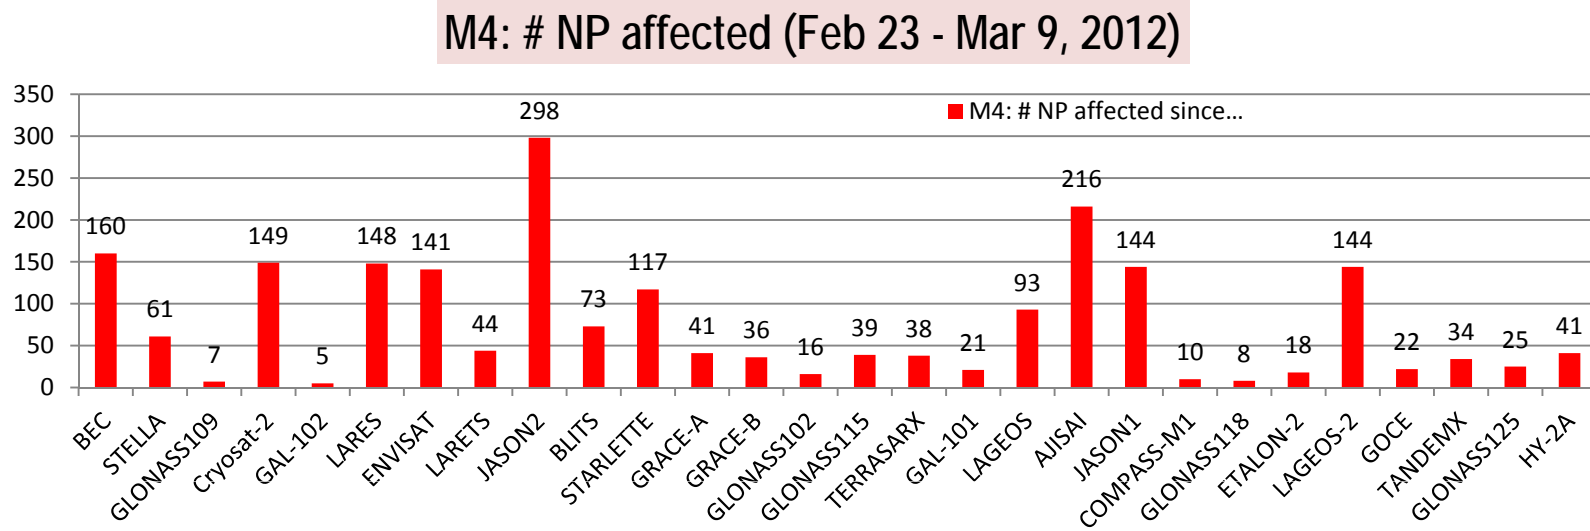
Moblas 4 Data: Range Bias (Feb 23- Mar 9, 2012)

1. Station Bias seems to take a reversal of the RB trend from prior years since December 2011, though this is less clear;
2. Since Feb 23, RB distinctly shows a divergence (>7 cm on Lageos) from its past multi-year value (~2 cm for Lageos); the RB magnitude is >4 cm for Ajisai and >25 cm for Etalon (only one pass is available); <see attached chart>

3. The above change followed a routine HW (Time Interval Counter) change; problem could be due to one or more of the following problems: (a) counter (high probability) gone bad; (b) frequency source feeding the counter has gone astray; (c) noise source on the frequency output, (d) interfacing cables are bad, (e) TIC clock was set on Internal vs. External.

4. Observed bias (varying with satellite Range), if found to be predictable with range, may be correctable at the 1cm level for the above period;
5. Since the signature is explicitly clear and attributable to a known event that happened, we have an effort underway to replace the suspected pieces of HW, which includes the Counter and Station Time and Frequency Standard;

6. Above Hardware will go into the station effective Mar 14, 2012;
7. Todate we have 198 Satellite Pass Segments and associated 2149 NP affected by this problem in CDDIS data archives. <see attached chart>

- Engineering recommends the station to be put under **quarantine** at the present time;
- Standard quarantine protocol for data flow to be followed;
- Station will replace the hardware on Mar 14, 2012 and will subsequently collect data with particular emphasis on Lageos, Etalon, Starlette, and Stella, departing from the ILRS priority;

- Station is scheduled to take Test Data from Mar 9-Mar 14 to provide the basis required to correct (if error is systematic) the data since Feb 23 to date;
